Investigative Report

Test Cell 831 Druck Pressure Transducer Failure on  
March 25, 2003

May 5, 2003

Issued By  
National Aeronautics and Space Administration  
Johnson Space Center  
White Sands Test Facility  
Laboratories Office

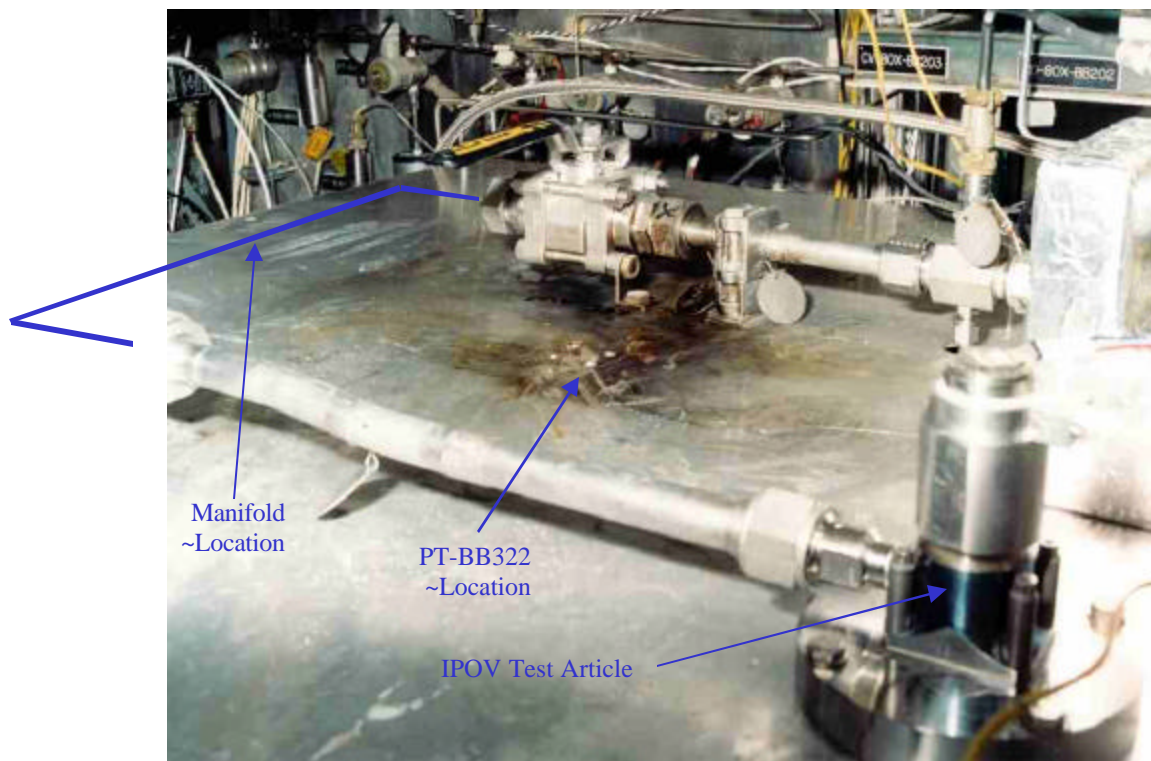
Figure 1: Location of Failed Pressure Transducer in Test Cell 831

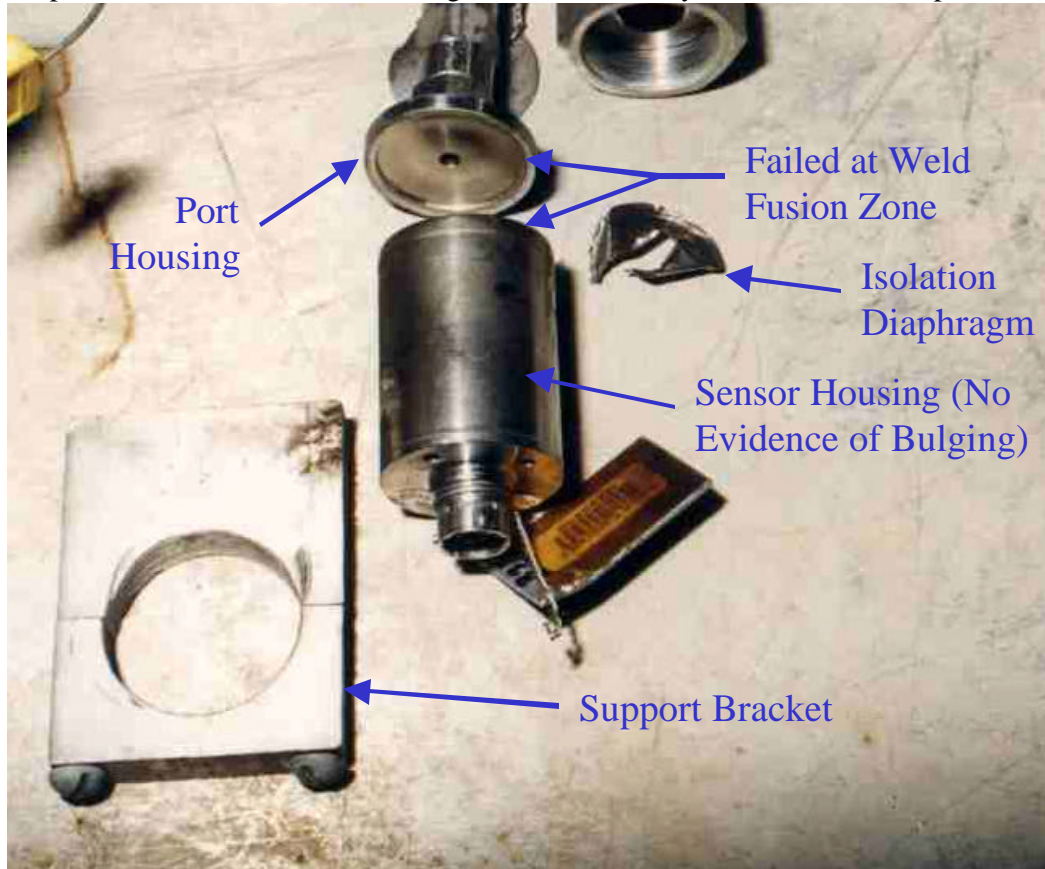
The pressure transducer failed at a welded connection between the port housing and the sensor housing (see Figure 2). The weld appears to be an electron beam weld (EBW) butt weld configuration and failure is from longitudinal stress in the weld fusion zone. The pressure to fail this welded connection was calculated to be 12,700 psi (reference calculation JCA-1780). The ¼ X 0.035 wall 300 series stainless steel tubing connecting the pressure transducer to the ¾ X 0.035 inch wall 300 series stainless steel manifold tubing failed close to the larger tubing. The ¼-inch tubing was significantly deformed and damage appeared to be from thrust generated when the pressure transducer failed. Based on measuring the outside diameter in several locations, the ¾-inch tubing showed no sign of yielding due to pressure. This indicates that the system pressure did not exceed the calculated 3,400 psi required to yield this tubing (reference calculation JCA-1777). The failed diaphragm has a small diameter central area that is bulged and ruptured, which matches the inlet port flow passage diameter (see Figure 3). The calculated pressure to burst the diaphragm when supported at the port diameter is ~4,000 psi (reference calculation JCA-1784). Based on these observations, the Failure appears to be the result of extremely rapid over-pressurization inside the pressure transducer that first exceeded

Figure 2: Failed Druck PDCR 130/W/C Pressure Transducer

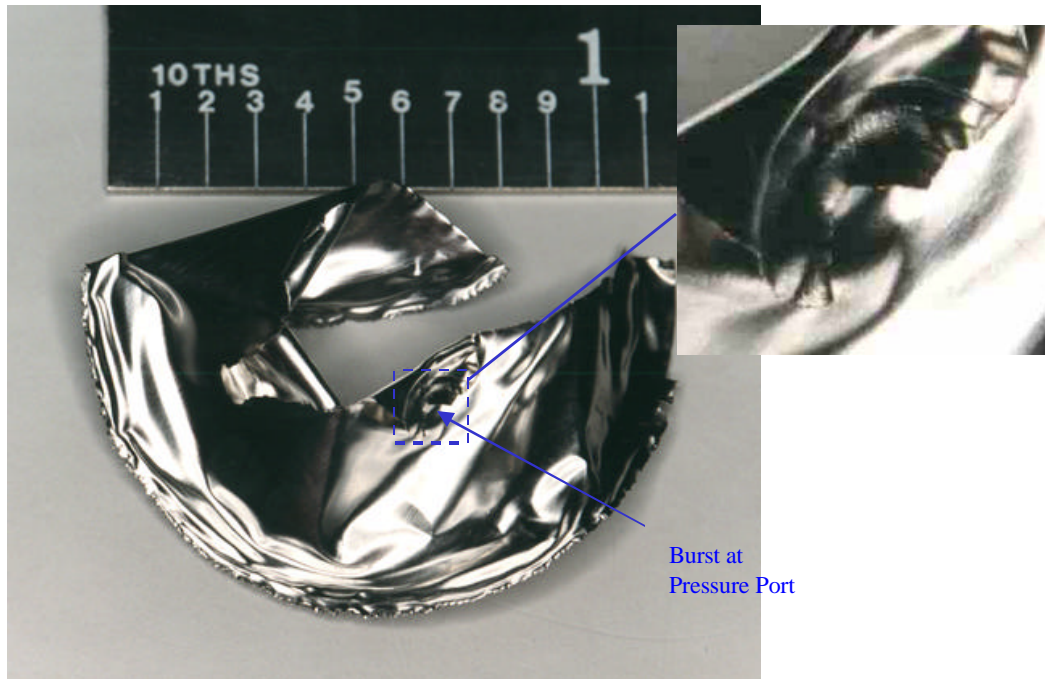
Figure 3: Failed Isolation Diaphragm

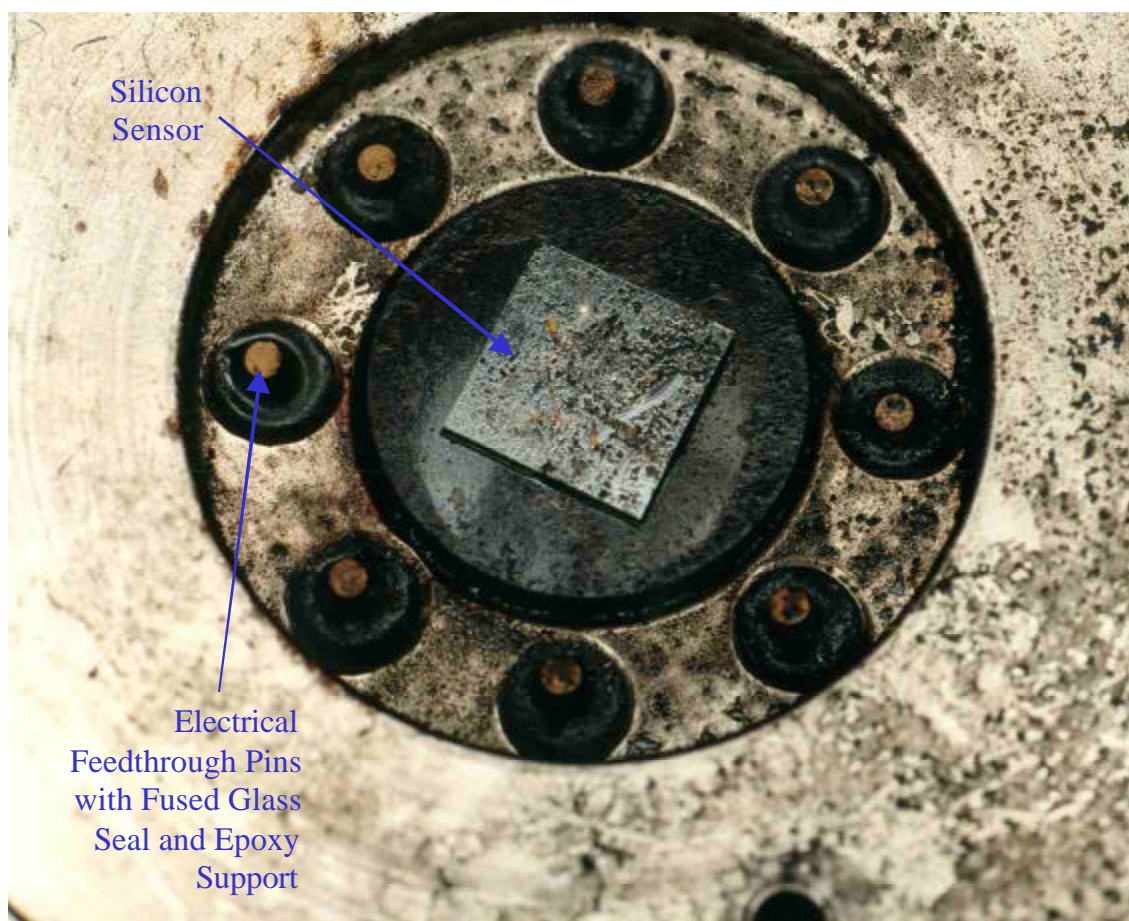
the ~4,000 psi diaphragm burst pressure. Flow through the 0.157 inch port flow diameter was inadequate to relieve the over-pressure thus enabling the pressure to reach the ~12,700 psi housing burst pressure. After burst, sufficient thrust was achieved to deform and then fail the 1/4-inch pressure transducer connecting tubing. The sensor location of the pressure transducer is shown in Figure 4. Note the oily residue seen in this photo.

Figure 4: Failed Transducer Sensor

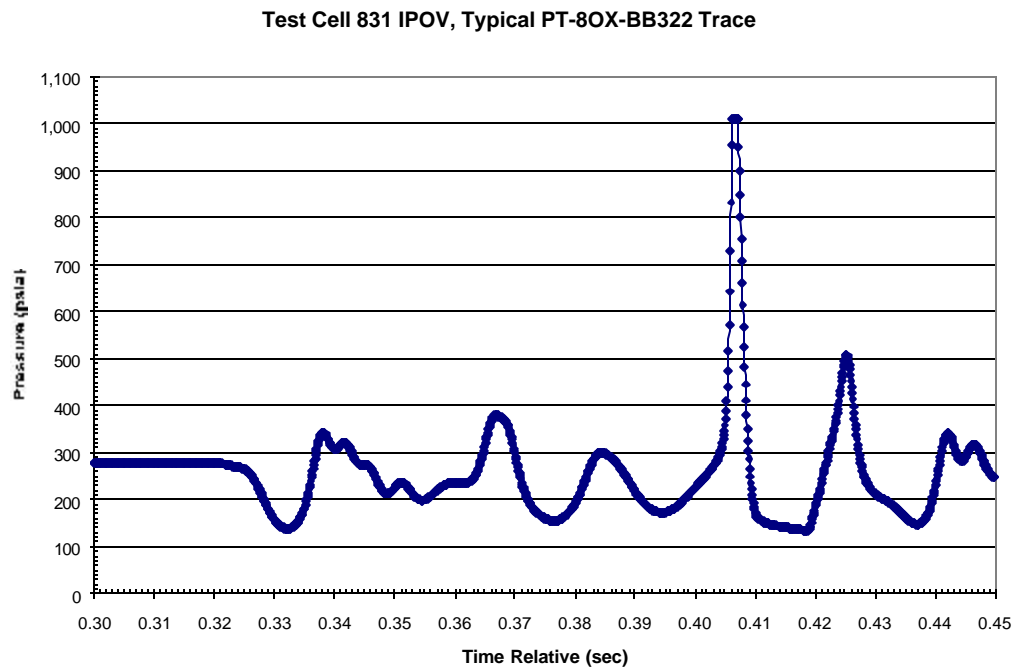
The high speed data from PT-BB322, prior to the time when PT-BB322 ceased to provide output data, was analyzed to determine the pressure that this portion of the system was subjected to. Figure 5 shows a typical pressure trace. The data indicates that the dynamic pressure exceeded the 0 to 1,000 psia scaling, resulting in clipped data.

Figure 5: IPOV Inlet Pressure Measured by PT-BB322 Prior to Failure

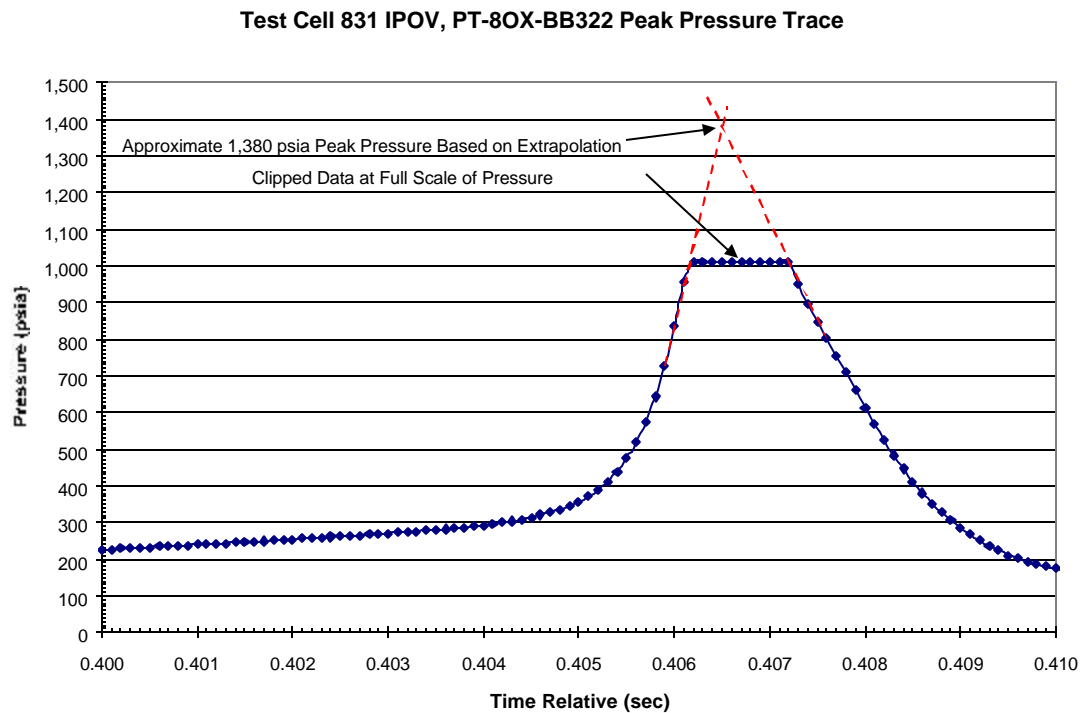
Figure 6 has an expanded time scale during the peak pressure. Extrapolation of the leading and trailing edges of the trace was used to approximate the peak pressure at 1,380 psia. Future testing should use a transducer with appropriate range (0 to 1,500 or 0 to 2,000 psia) and scaling. Test system modification is being considered to limit peak pressure but the first runs are planned with existing configuration to determine the magnitude of the peak pressure.

Figure 6: IPOV Inlet Pressure Measured by PT-BB322 Prior to Failure, Expanded Time Scale

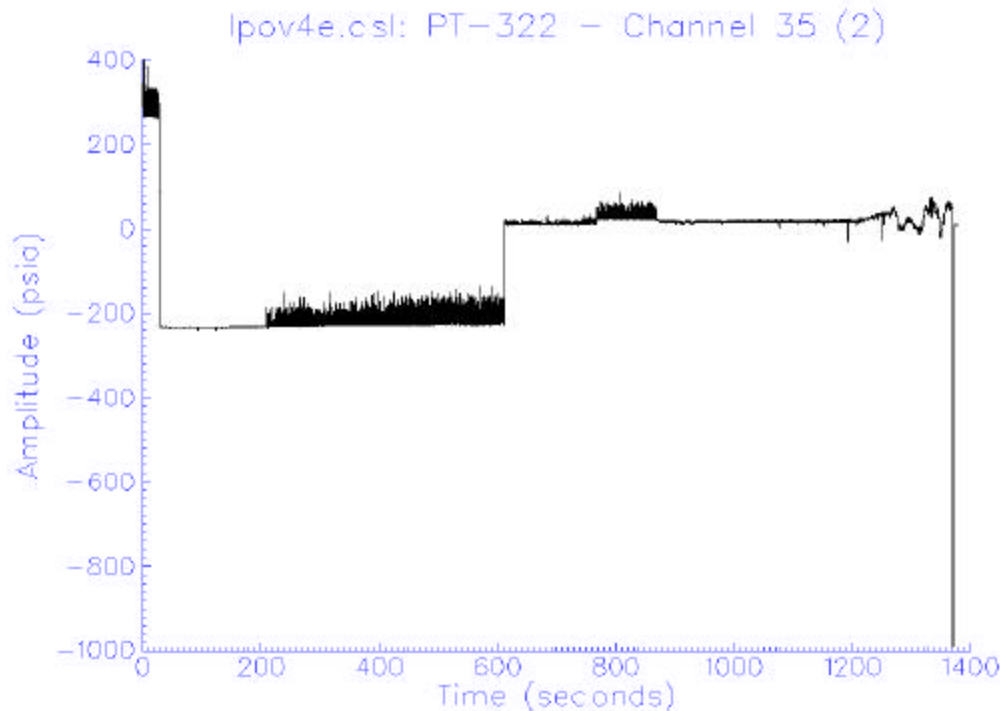
The slow speed data for PT-BB322 and FM-BB325 was analyzed to determine when PT-322 no longer responded to the IPOV inlet pressure and the time delay before failure. At ~28 seconds after the test series began, the output from PT-BB322 shows a dramatic change and loss of response. At ~1,369 seconds after the test series began, FM-BB325 indicates a flow rate of ~1 lb/sec during the zero flow portion of the IPOV test cycle, indicating external leakage. Safing of the test system is observed ~7 seconds later based on the decreased flow rate after isolation valve closure and discontinuation of the test cycles. Based on this information, the time between PT-BB322 sensor failure and catastrophic pressure transducer housing failure was 1,341 seconds or 22.4 minutes. The real time output for PT-BB322 is a digital readout on a computer monitor. The loss of the pressure transducer output was not observed until later data analysis. Based on a flowrate of 1.05 lb/sec when the IPOV was no longer flowing, 7.3 seconds until system shutdown, and the data recorded during system venting through the failed ¼-inch line, the NTO loss during the failure was ~9.0 lbs or 2.8 liters.

Figure 7: PT-BB322 Output Showing Loss of Function at ~28 Seconds

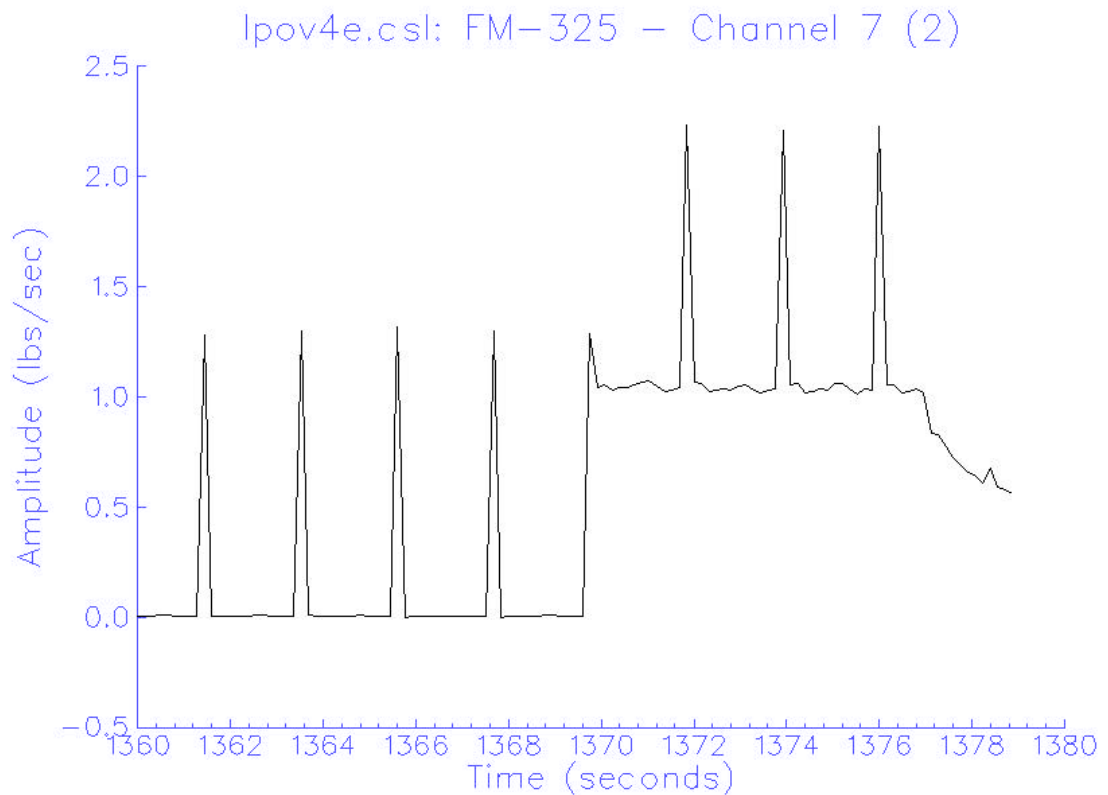
Figure 8: FM-BB325 Output Showing Increased flow at Failure and System Safing

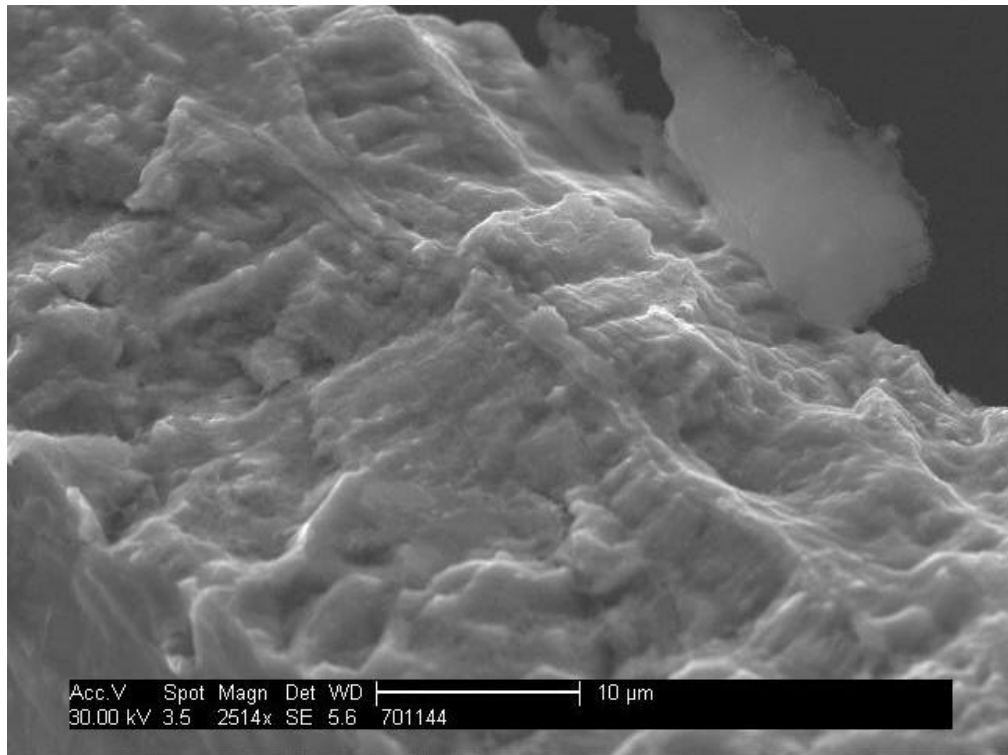
The pressure port housing and the recovered section of the isolation diaphragm were submitted to the Materials Technology Group under LWO 701144 for analysis of the fracture surfaces. The diaphragm exhibited evidence of fatigue fractures, as shown in Figure 9, propagating from multiple initiation sites. Transgranular, partial penetration, secondary fractures were also observed on the diaphragm surface adjacent to and aligned with the through-thickness circumferential fracture, as shown in Figure 10.

Figure 9: Scanning electron photomicrograph of crack arrest marks and fatigue striations observed on the circumferential diaphragm fracture.

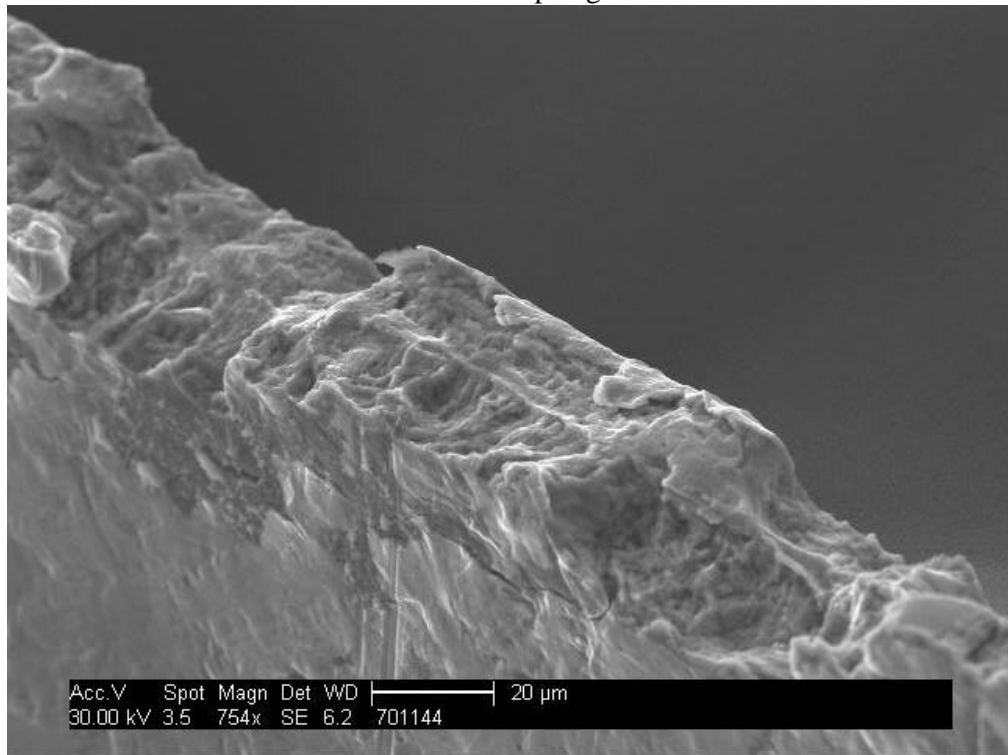
Figure 10: Scanning electron photomicrograph of crack arrest marks observed on the circumferential diaphragm fracture. Note also the transgranular, partial penetration, secondary fractures on the diaphragm surface adjacent to and aligned with the through-thickness circumferential fracture.

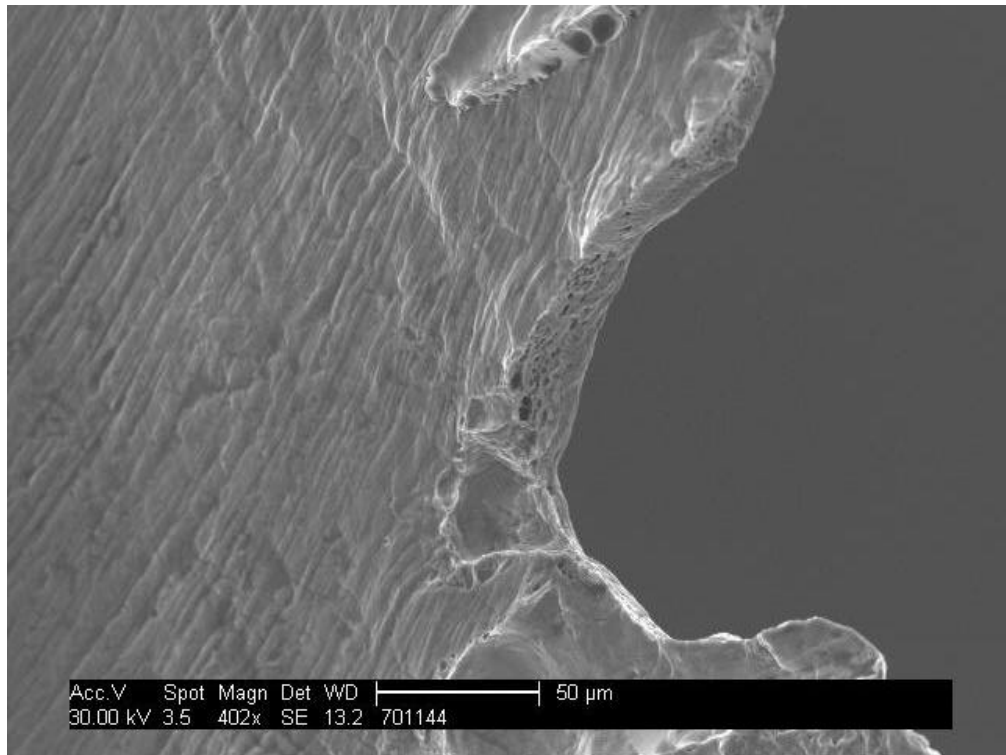
The remainder of the diaphragm fracture surface was described as ductile overload rupture, as shown in Figure 11. No evidence was found that indicated the fatigue fractures were initiated by environmental degradation or a metallurgical discontinuity. X-ray microanalysis indicated the isolation diaphragm alloy was a molybdenum bearing austenitic stainless steel, consistent with the manufacturer's specification stating 316 stainless steel. The results of microstructural analysis and microhardness testing indicated that the isolation diaphragm material is in the annealed condition.

Figure 11: Scanning electron photomicrograph of elongated dimples observed on the circumferential diaphragm fracture at the EBW root, indicative of ductile behavior.

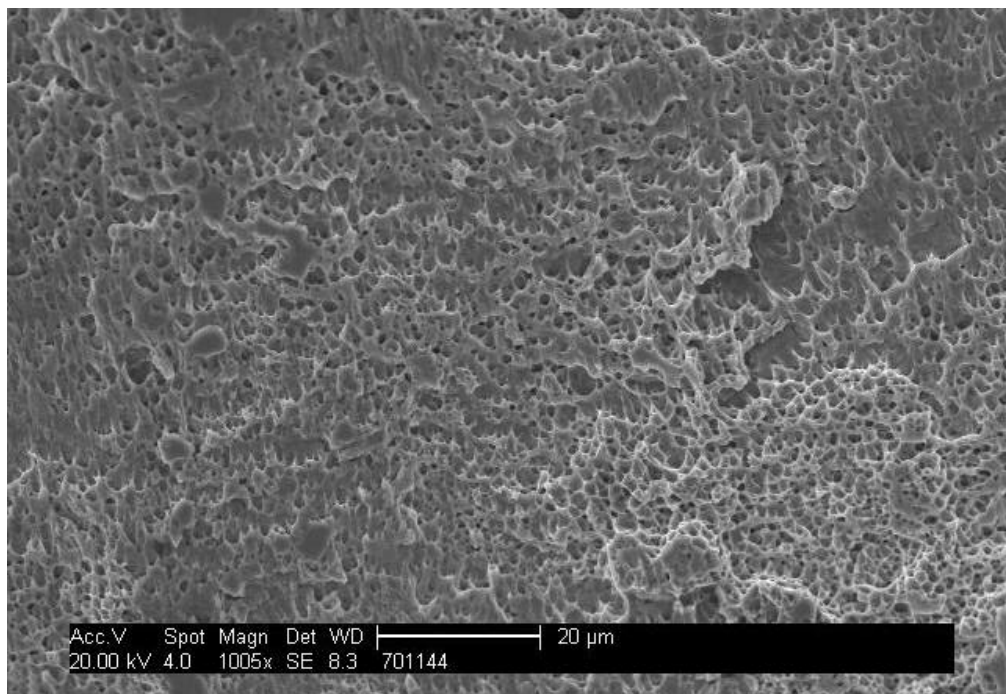
The transducer housing fracture, which occurred at the weld fusion zone, was found to be a ductile overload failure resulting from a single load application based on analysis of the pressure port end fracture surface, as shown in Figure 12.

Figure 12: Scanning electron photomicrograph showing elongated dimples on the circumferential pressure port end fracture surface, indicative of a ductile-type overload

rupture.

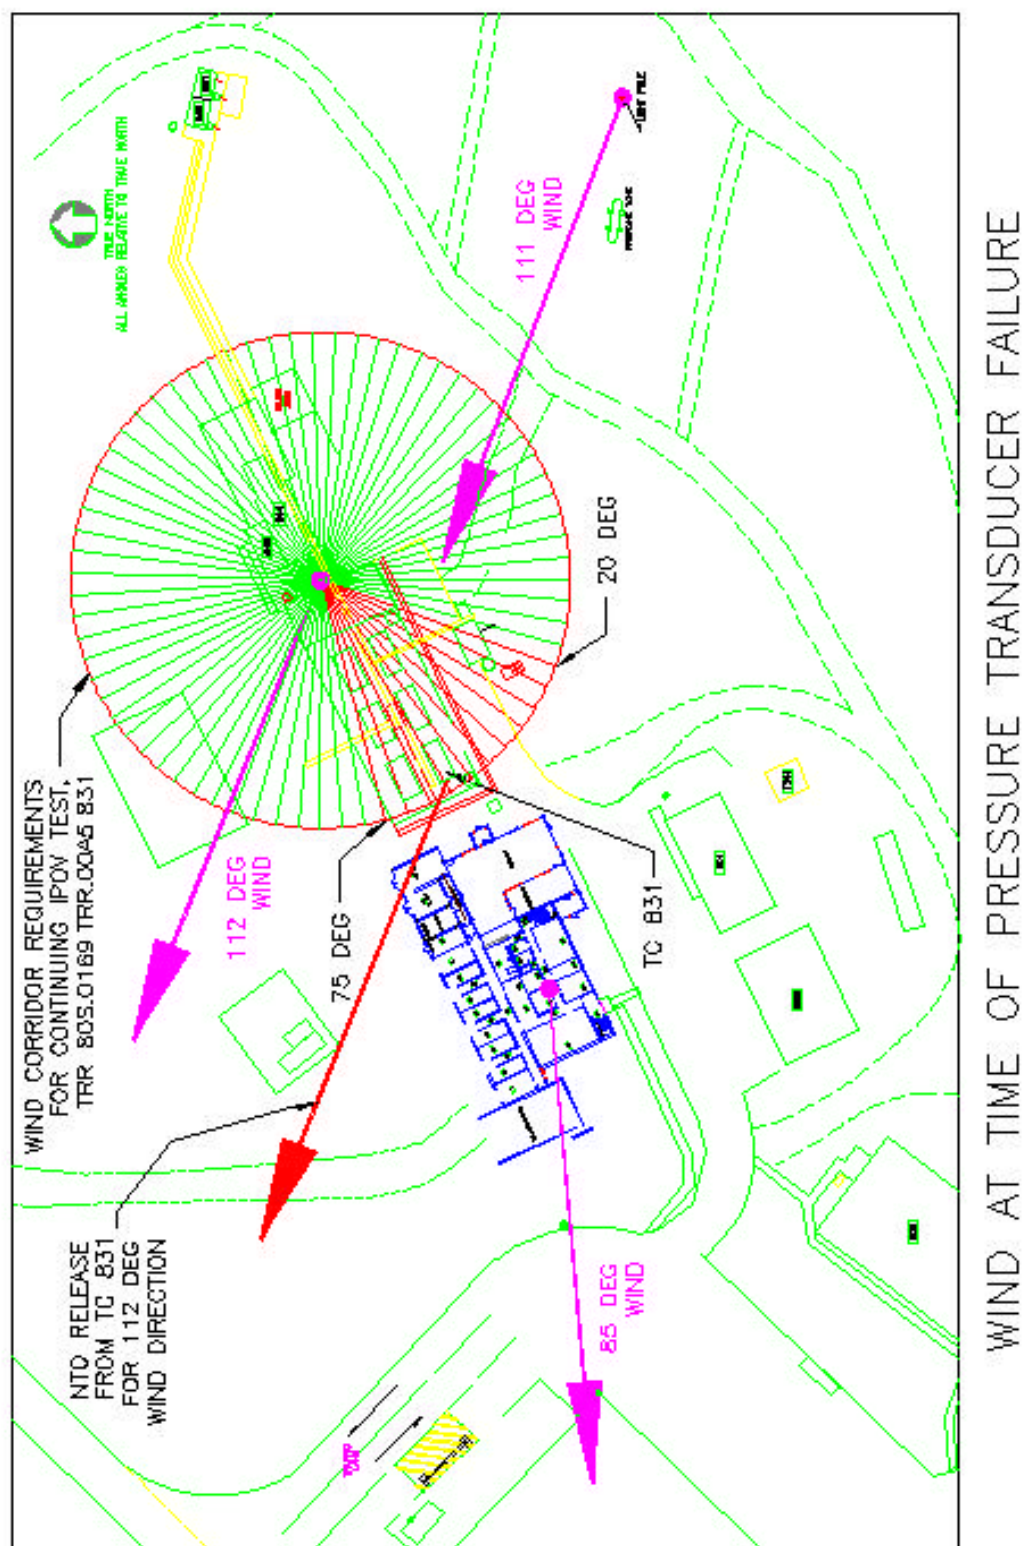
NTO vapor was detected in the HPTA after the Test Cell 831 failure. Data of the wind direction and speed is available and was reviewed. The IPOV life cycle testing was being performed after hours. The wind corridor required to begin testing is the same as for standard operations but the wind corridor to continue testing was expanded. A TRR amendment for IPOV Life Cycle Testing (TRR 80S.0169.TRR.00A5.0831) approved the wind corridor modification for this test. The wind data for March 25, 2003 at 19:00 hours was reviewed and results of the wind direction at the three sensor locations is included on a facility plan view in Figure 13. The NTO release direction was included, based on the wind direction at this point being the same as at the wind sensor close to Test Cell 844, which is the controlling wind sensor for wind corridor decisions. The expanded wind corridor for the IPOV test was also included. Based on this information, the wind would have blown the NTO vapor over the northeast corner of the newly built HPTA cells 130, 131, and 132. The HVAC fresh air intake for this HPTA addition is on the east end of the addition and directly in the path of the NTO vapor release. Designing the HVAC system with the fresh air intake at the west end would have been preferable to avoid sucking propellant vapors into the HPTA. The HFTA wind corridor was further restricted to avoid potential propellant release over the corner of the HFTA or the north to south road east of the Control Room (Hazardous Fluids Test Area Safe Wind Corridor Memo of Record, April 23, 2003, 80P.0228.MEMO.0000.0000).

**Figure 13: Wind at Time of Pressure Transducer Failure**

- 7.4 Reevaluate the HFTA wind corridor to ensure that a release at the end of the HFTA closest to the control room and HPTA is safely controlled. Note that the "Hazardous Fluids Test Area Safe Wind Corridor Memo of Record" (80P.0228.memo.0000.0000) was prepared by the HTSI supervisor and has been approved.
